DOWNSTREAM ASSESSMENT

MOLODOW AND COLLINWOOD SITES

Town of Fairview

May 2020

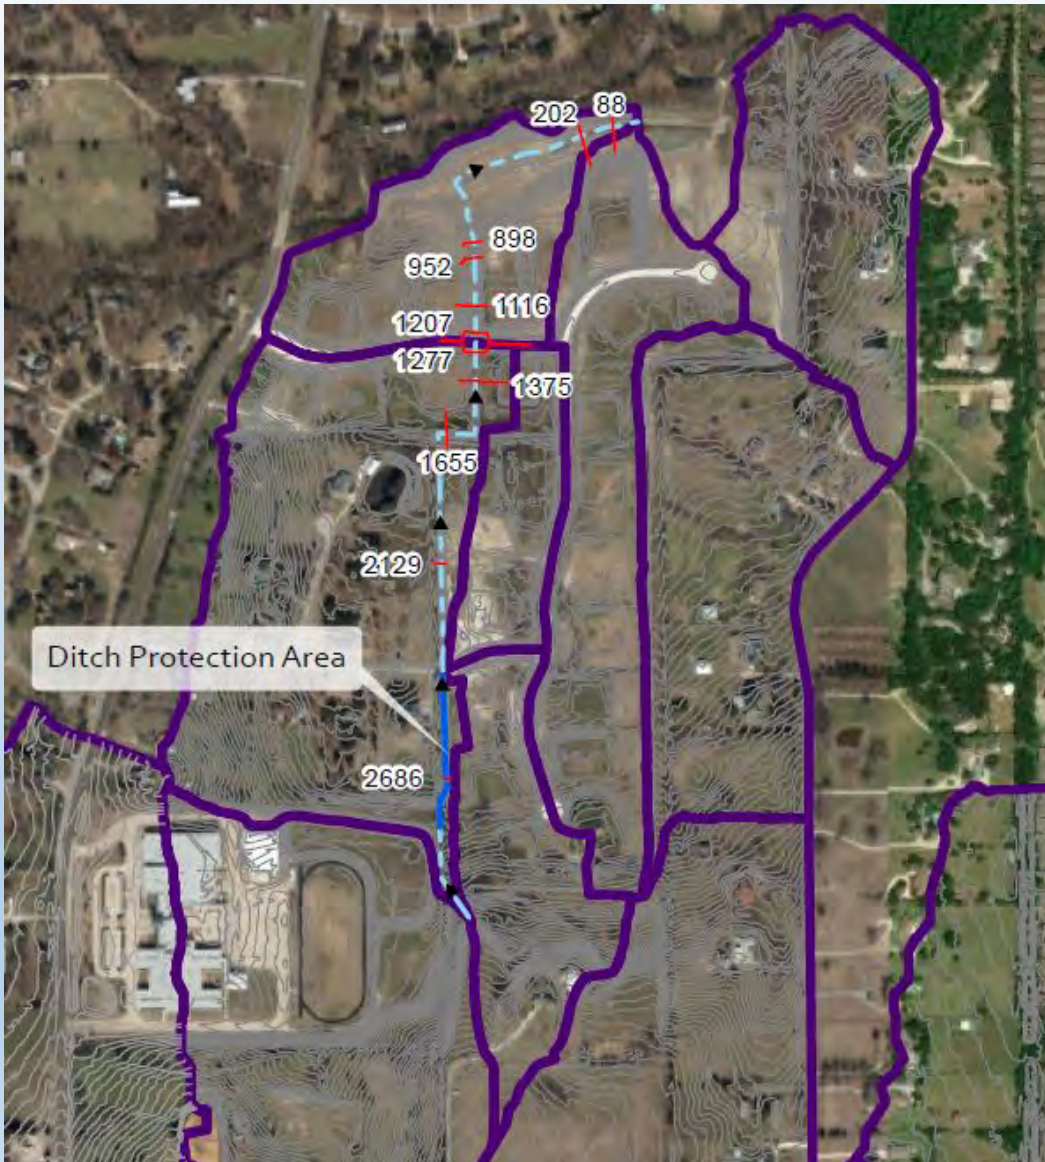
- Increase in Discharge to Existing Ditch Warranted a Hydraulic Analysis to Determine Impacts Downstream
- Results Indicate an Increase in Channel Velocity From 5.4 fps to 6.7 fps. Erosion Expected on Grassed Channel.
- Ditch has adequate Capacity to Convey Developed Flows, But Will Need to Be Protected To Prevent Erosion.
- Ditch Protection Limits Should Be From Site's Northwest Corner to Homestead Drive. Ditch Should Be Extended to Site's Northwest Corner.
- Channel Velocities d/s of Homestead Drive Also Increase, But Are Non-Erosive.

- Flows in The Existing Ditch Will Increase, Causing Higher Channel Velocities. A portion of The Ditch From The Site's Northwest Corner to Homestead Drive Should be Protected to Prevent Erosion.

- Alternatively, In Lieu of Discharging Into Existing Ditch, Site Runoff Could Be Directed to School Pond to Be Detained And Released at A Lower Rate Into Ditch. This Would Require The Existing Pond to Be Expanded to Provide An Additional 1 Acre-Ft of Storage And Potential Modification to The Outfall Structure, But Would Not Require Protection To The Existing Ditch.

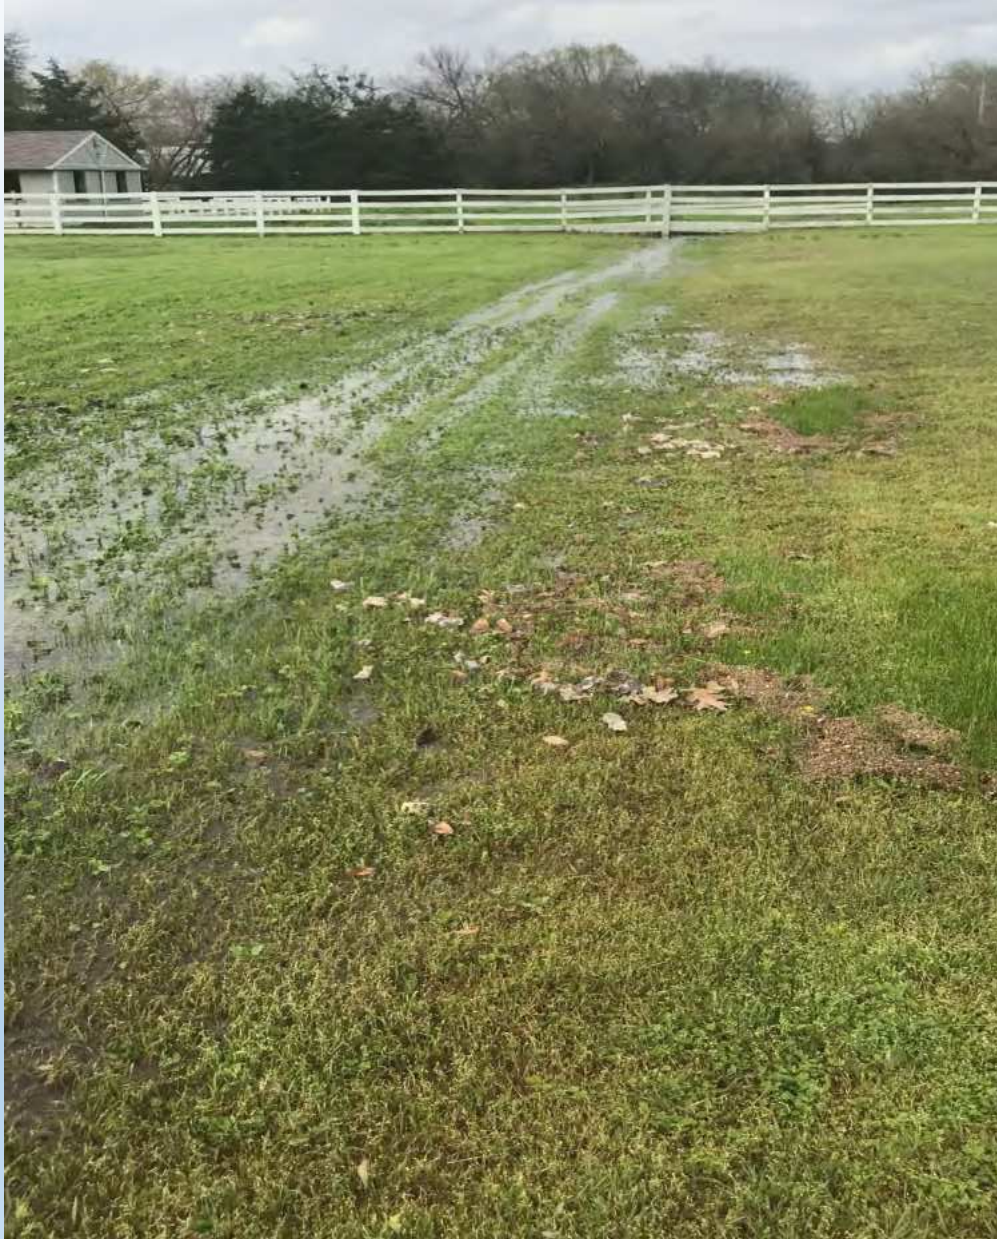
480 Home Place – Holly Parsons

- Backyard floods and takes several days to dry
- No way for City to control what residents do within their lots that could adversely impact neighbors
- Would like to receive answers from the City within a reasonable timeframe

- Backyard floods due to large upstream watershed draining through yard. Town may consider regulating streams draining large areas. This would require easements dedicated to the Town.
- Grading a swale though this and downstream properties will alleviate flooding.
- More structured process for receiving and answering resident's concerns within a timeframe.
- Identify need for additional resources.

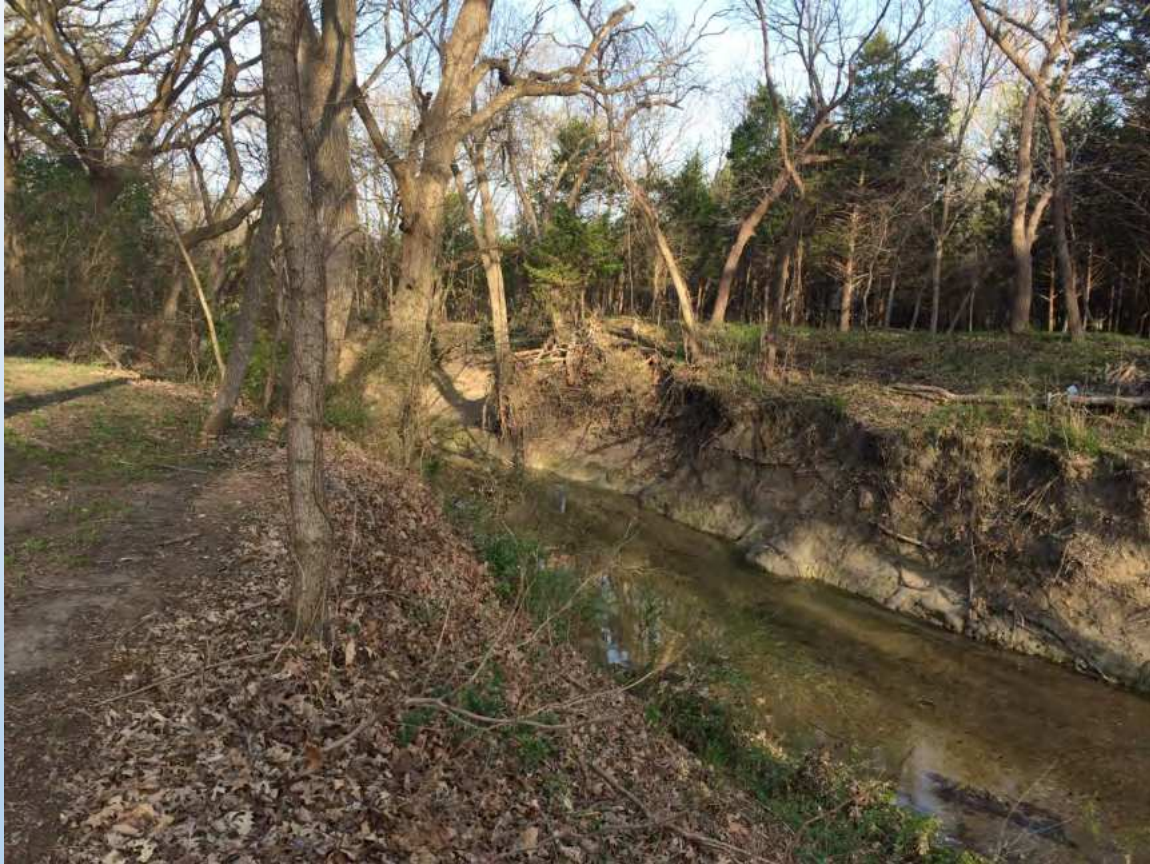
540 Hackberry Drive – Cory Zuerker

- Resident understands his property is within floodplain and is expected to flood frequently
- No increase in flooding frequency, except for 2015
- Erosion taking place along Sloan Creek streambanks

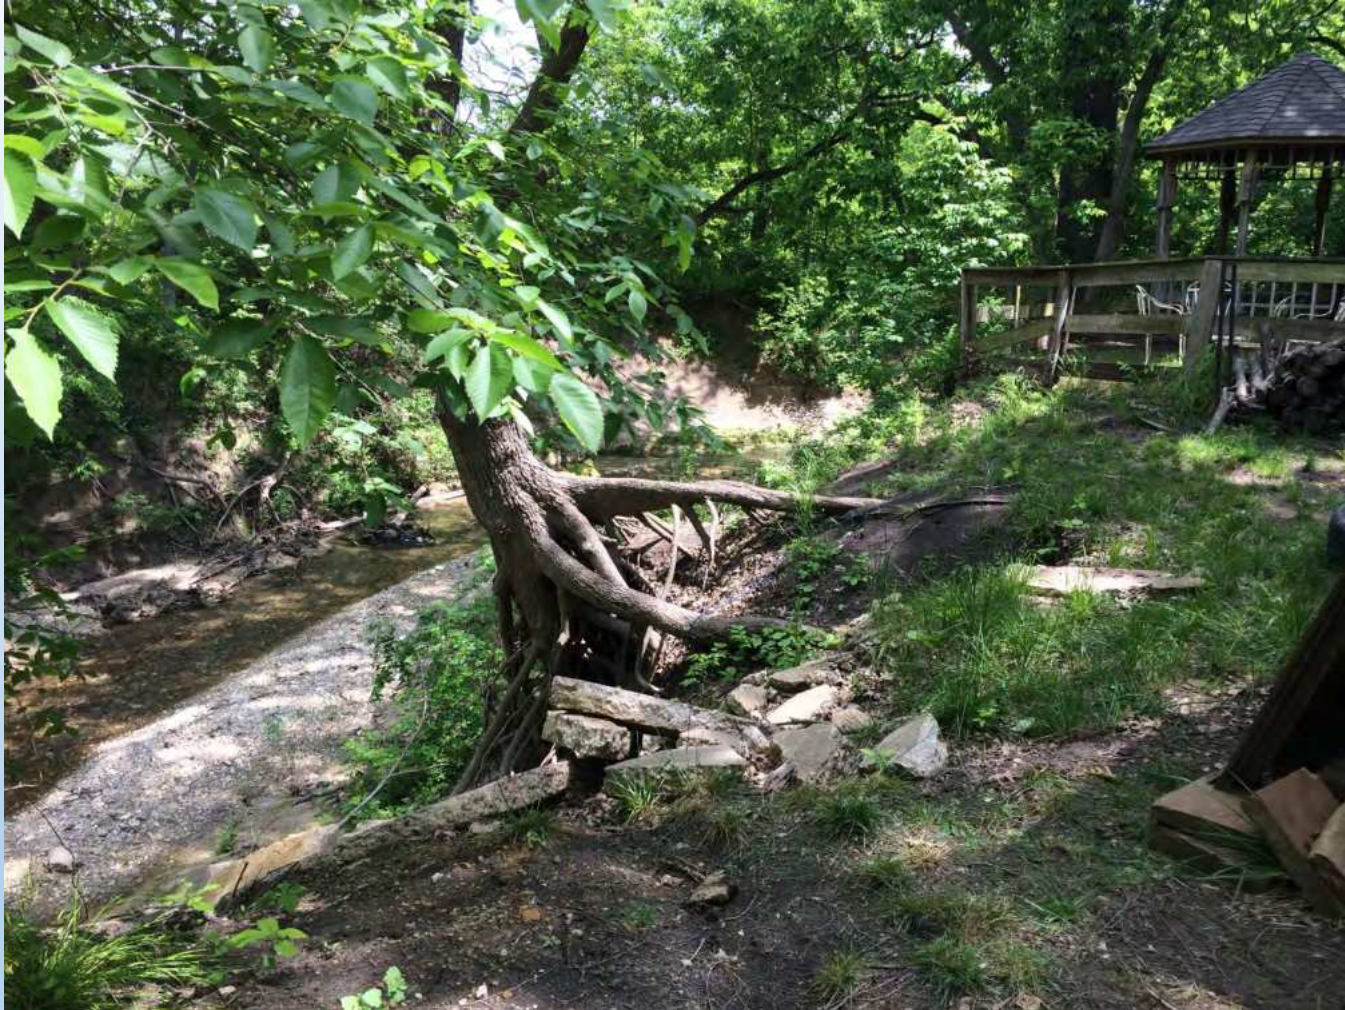
Rachelle Farkas (and Foxglen neighbors) – 1041 Pecan Drive

- Street floods and takes up to 2 weeks to dry out, allowing for bad smell, mosquito and algae growth.
- Severe streambank erosion caused loss of yard up to 15-ft and large trees in backyard to fall and be carried down Sloan Creek

- Swale between lots providing positive drainage will drain water from street to Sloan Creek
- Streambank protection highly recommended to stop bank erosion.

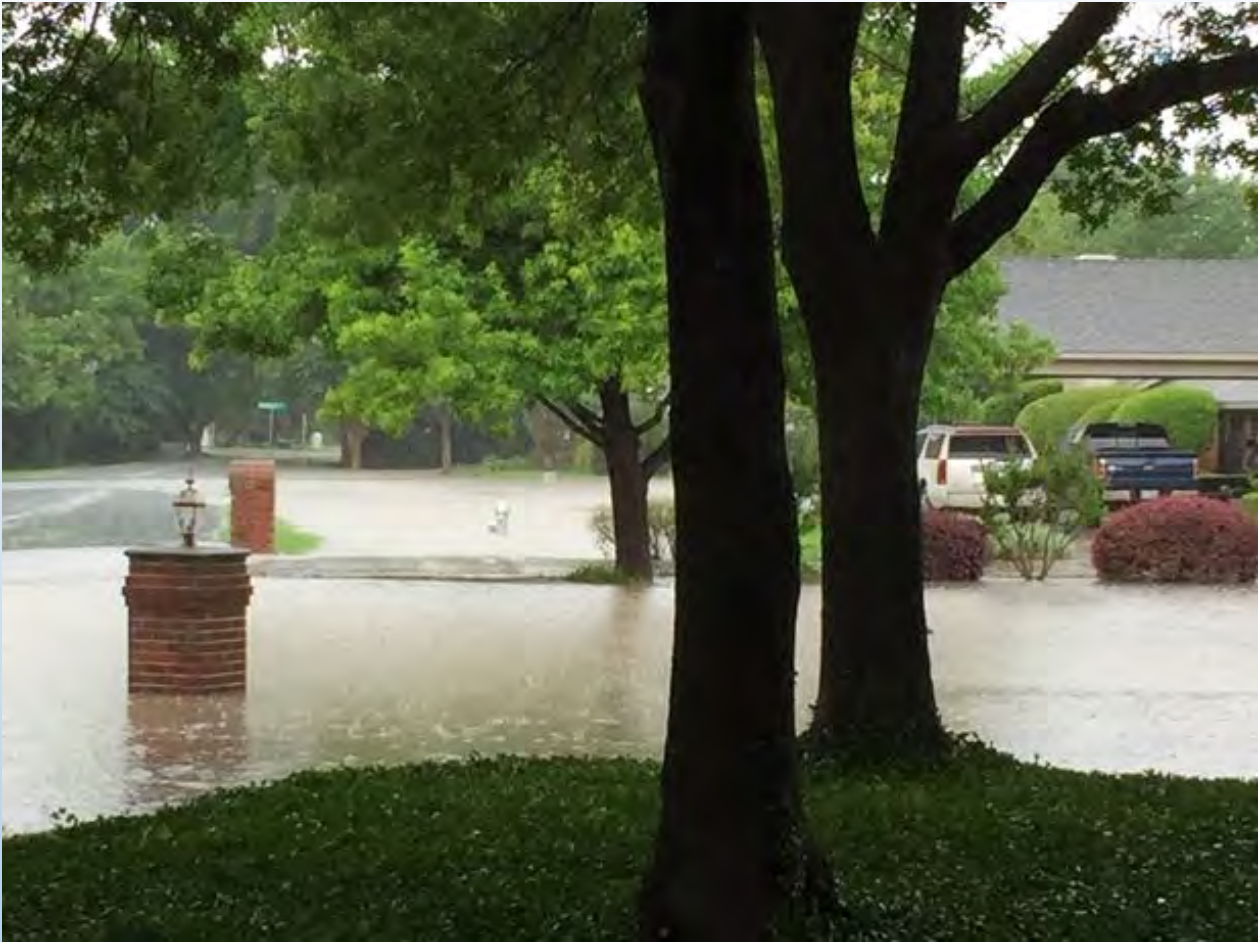
1060 Pecan Drive

- Homeowner believes more frequent flooding in his front yard is due to his neighbor's driveway being raised, constricting the natural drainage path.

- Increasing the culvert opening under the recently raised driveway is expected to decrease front yard flooding and restore drainage back to or similar to its original condition.
- Increase in frequency of flooding also due to greater rainfall amounts seen in the past 5 years.

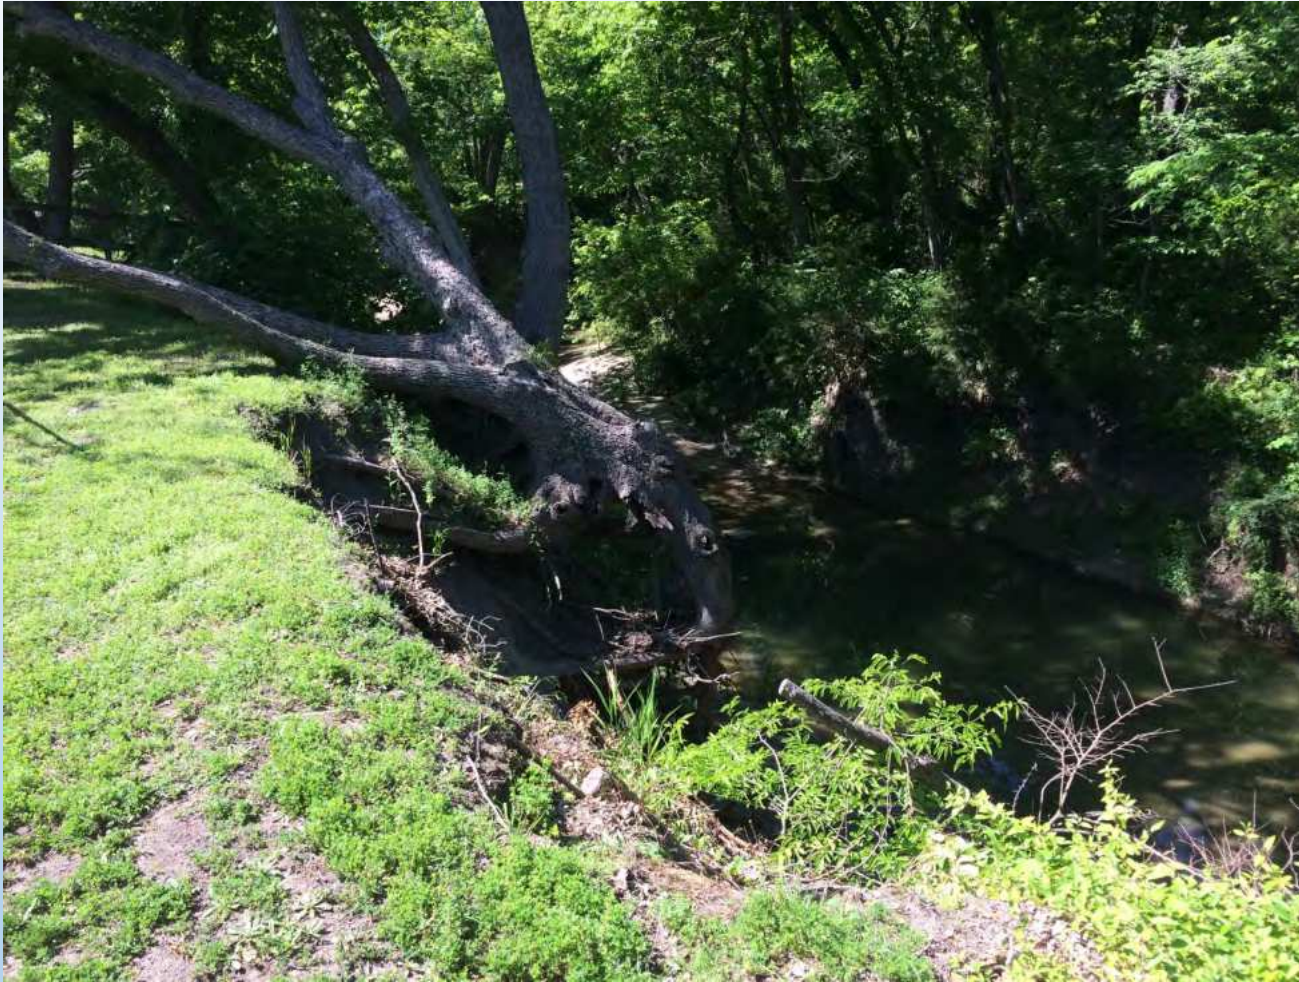
580 Maple Lane

- Severe streambank erosion has caused the loss of as much as 20-ft of yard at three different locations.
- Large trees have fallen into the creek due to bank erosion
- Concerned about continuing trend of erosion causing additional loss of yard and large trees.

- Streambank erosion is the most severe out of all the properties observed.
- Immediate streambank protection is highly recommended to prevent further bank erosion, loss of land and trees.
