Huitt-Zollars, Inc.

East Fairview Drainage Study

Town of Fairview

October 08, 2020

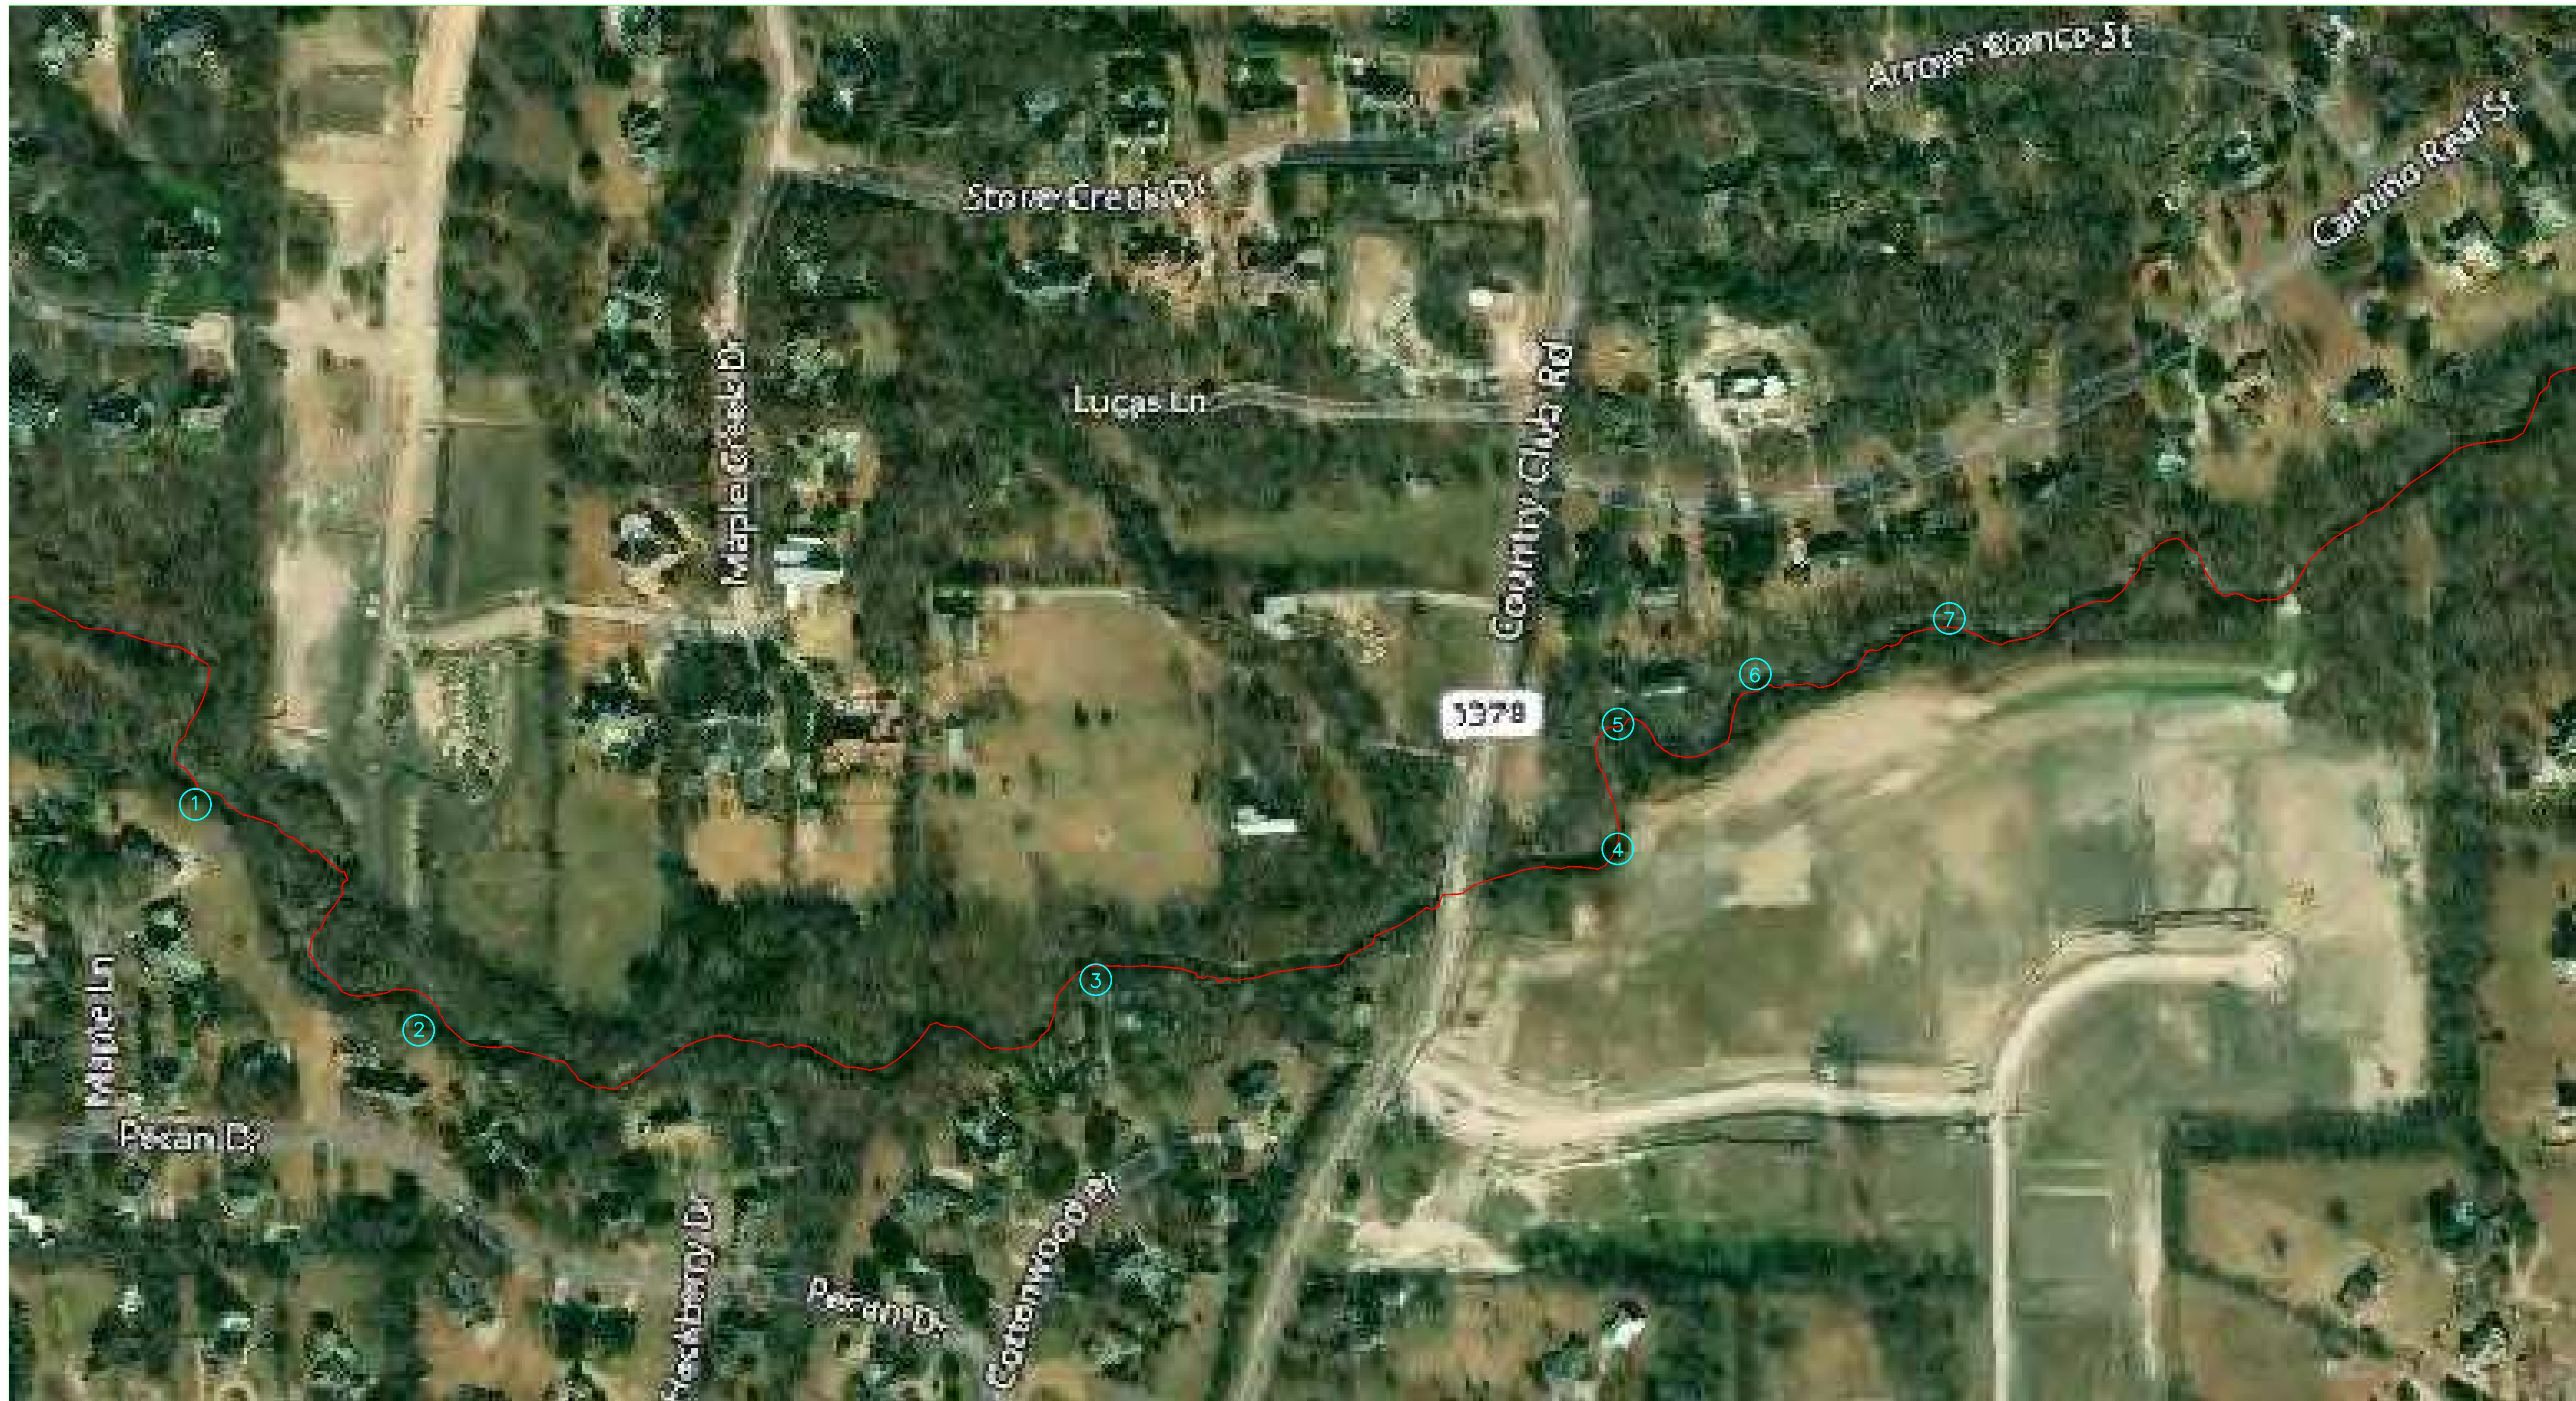
EAST FAIRVIEW MITIGATION ALTERNATIVES		
EROSION CONTROL SITES		
TOWN OF FAIRVIEW COLLIN COUNTY, TEXAS		
HUITT-ZOLIARS <small>Huitt-Zollars, Inc. Engineering / Surveying 1717 McKinney Avenue, Suite 1400 Dallas, Texas 75202-1236 Firm no. F-761</small>	SCALE AS NOTED	SHEET No.
	DATE JUN 2020

This study included observation of reported erosion sites in Foxglen and a field evaluation of Sloan Creek between Harper Landing and the homes on Camino Real. Huitt-Zollars staff walked along the stream to determine the areas undergoing severe erosion, and to document vegetative cover, bank material, sinuosity, bank slopes, bank height, signs of streambed head cutting, aggradation and degradation around bends, and stream profile. Some parts of the stream could not be evaluated due to access difficulties related to the water level in the stream or heavy vegetation in the banks and overbanks. A total of 7 locations were identified as having undergone severe erosion, three in Foxglen and three east of the Country Club Road bridge. These locations are depicted in the map in the next page. An in depth analysis was performed to understand the erosion at each site and to provide recommendations for potential solutions.

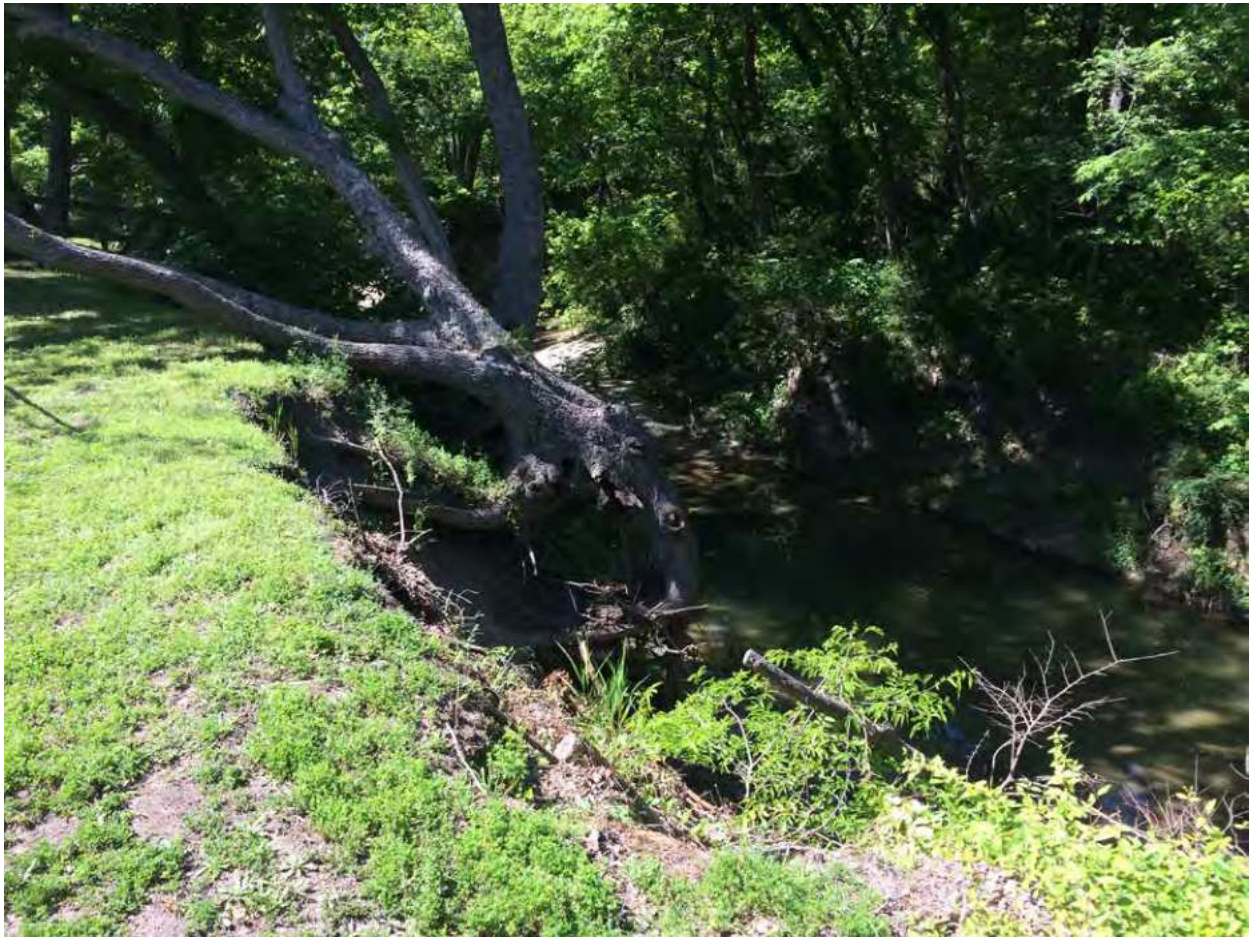
This area is located in the back of the property at 580 Maple Lane, where an unnamed tributary joins Sloan Creek. Erosion was observed in the unnamed tributary as well as the main stream. Bank height is approximately 15 feet. Bank slope is very steep, nearly vertical. Bank material is mostly clay. Natural vegetative cover consisting of brush, grass, bushes, and trees have been partially washed away exposing the bank in some areas, and uprooting large trees. Approximately 20 feet of overbank has been lost due to erosion. The main dwelling in the property is at a safe distance (at least 80 feet) from the eroded bank, but two secondary structures and a light pole guy wire are very close to it. The stream alignment in this area has sharp 90-degree bends causing the flowing water to hit the streambank perpendicularly. As vegetation is lost to erosion the site will become increasingly more susceptible to erosion. The effective hydraulic model for this area indicates the 100-year channel velocities are between 9 and 10 feet-per-second. These are high velocities with a high erosion potential, particularly with the loss of protective vegetation in the streambanks.

Severe bank erosion causing tree uprooting and loss of overbank

Site 1 – This site is located in a section of the stream with high velocities, sharp bends, soft bank material, and has suffered loss of natural vegetative cover. Given the site conditions, geometry, stream alignment and geology, it is unlikely that placing vegetation back in the bank will protect it from future erosion. A hard armoring alternative is the most adequate solution for this site. A hybrid solution combining bioengineering and hard armoring is also an adequate option for this site. Gabions are not recommended along Sloan Creek due to the size and quantity of tree logs and other materials that move through the creek that could damage the baskets. The recommended design is a reinforced concrete wall or concrete block wall up to half of the bank height, transitioning to a geogrid-reinforced slope with turf reinforcement mat used in conjunction with a native grass for the top part. Removal of trees and of one secondary structure, and relocation of the power pole guy wire would be necessary. This wall would be essentially maintenance free after construction. The length of the wall is approximately 220 feet and the construction cost would be approximately \$400,000.

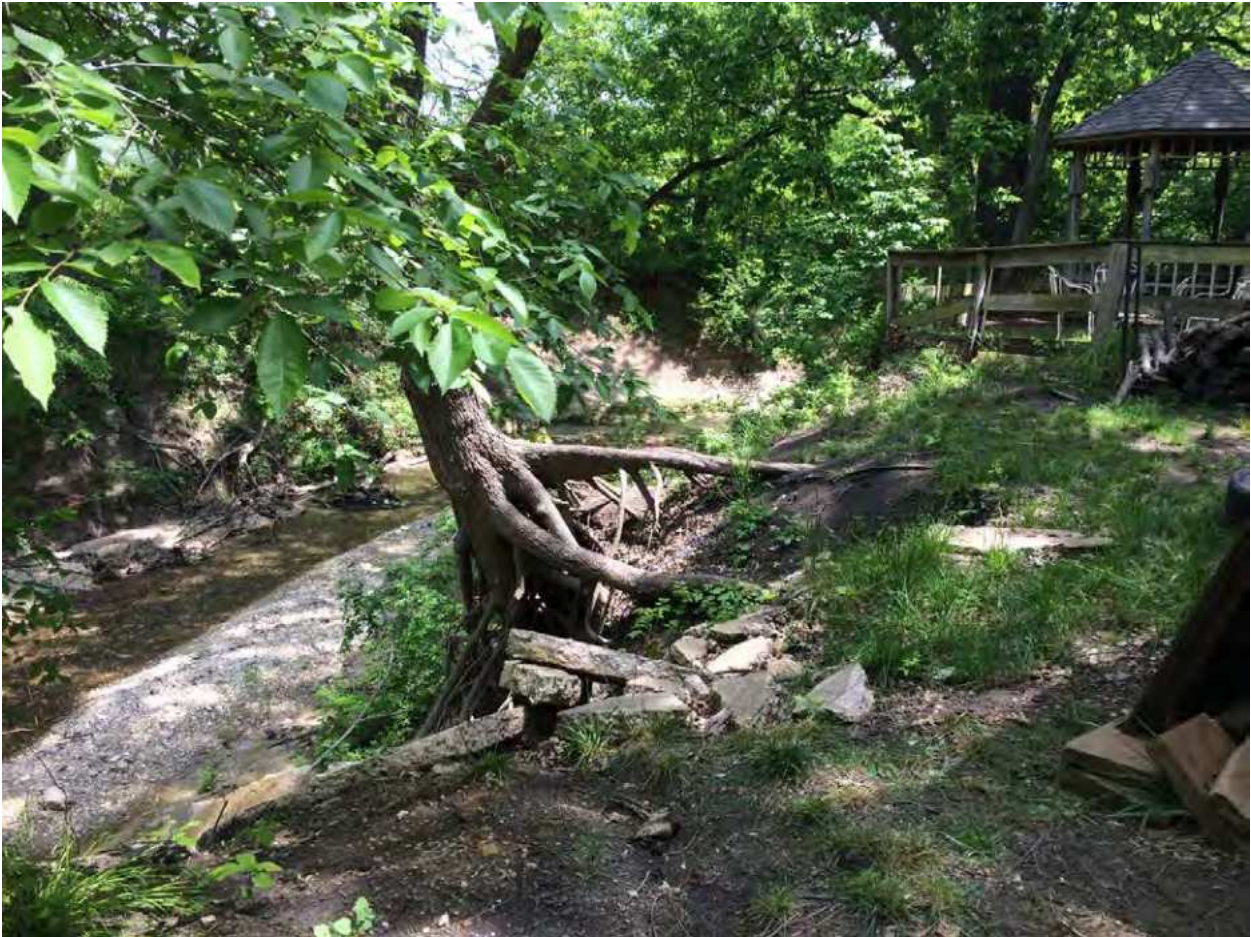
This site is in the back of the property located at 1041 Pecan Drive in the Foxglen neighborhood. Bank is approximately 16 feet in height, partially covered with grass, brush, and trees. Bank slope is approximately 1:1. Large portions of overbank has been lost due to erosion. Large trees have been uprooted and are in imminent danger of being washed away. This section of the channel is very sinuous, with curves and turns, which tend to make the banks more susceptible to erosion. The 100-year channel velocity in this area is between 7.6 and 10 feet per second, which are considered erosive velocities for a natural stream. The main dwelling is approximately 70 feet away from the bank. An existing gazebo sits near the top of bank, facing the potential for being washed away as erosion progresses.

Uprooted tree and gazebo in the background

Site 2 – The conditions at site 2 allow for the construction of an r-rap wall, possibly with geogrid soil-reinforcement, and a gabion foundation. This design would require removal of the gazebo and trees in the bank where the wall will be constructed. The retaining wall would be approximately 180 feet long and 16 feet in height. Construction cost would be between \$300,000 and \$350,000.

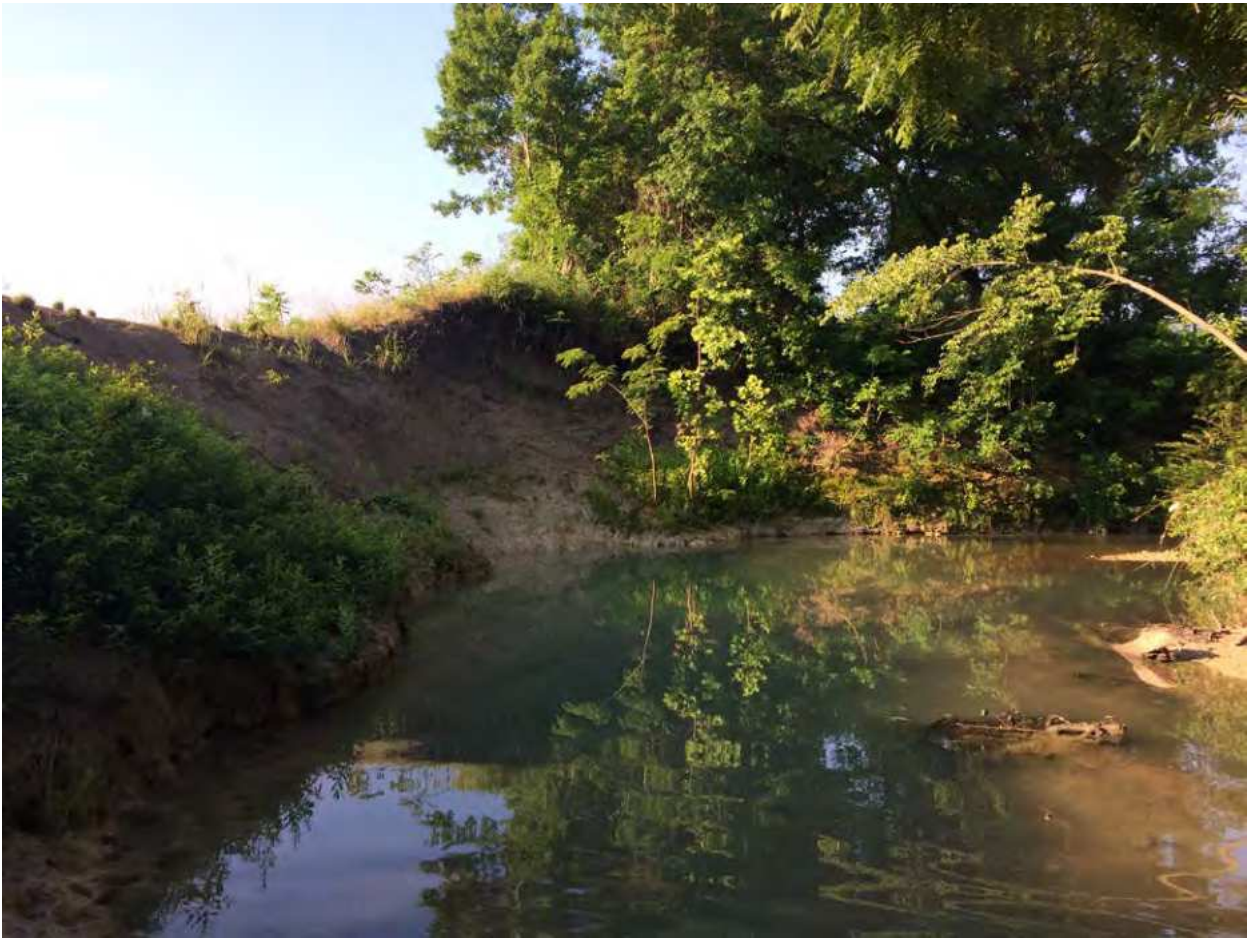
Site 4

This site is located 200 feet east of the Country Club Road bridge. The erosion has taken place around a sharp bend in the stream, which appears to be the area graded to allow the flow from the main creek to enter the overflow channel constructed with the Harper Landing development. Bank material is a sandy clay type, which is not resistant to high forces from flowing water. Currently there are no structures in the property. The HEC-RAS model shows a 100-year channel velocity of 18 feet per second in this area. The main reason for this extremely high velocity is the location just downstream of the bridge, where contraction and expansion coefficients are higher and the flows are constricted through the bridge causing downstream velocities to increase. Erosion is expected to continue along the stream bend.

Erosion along sharp bend on the stream

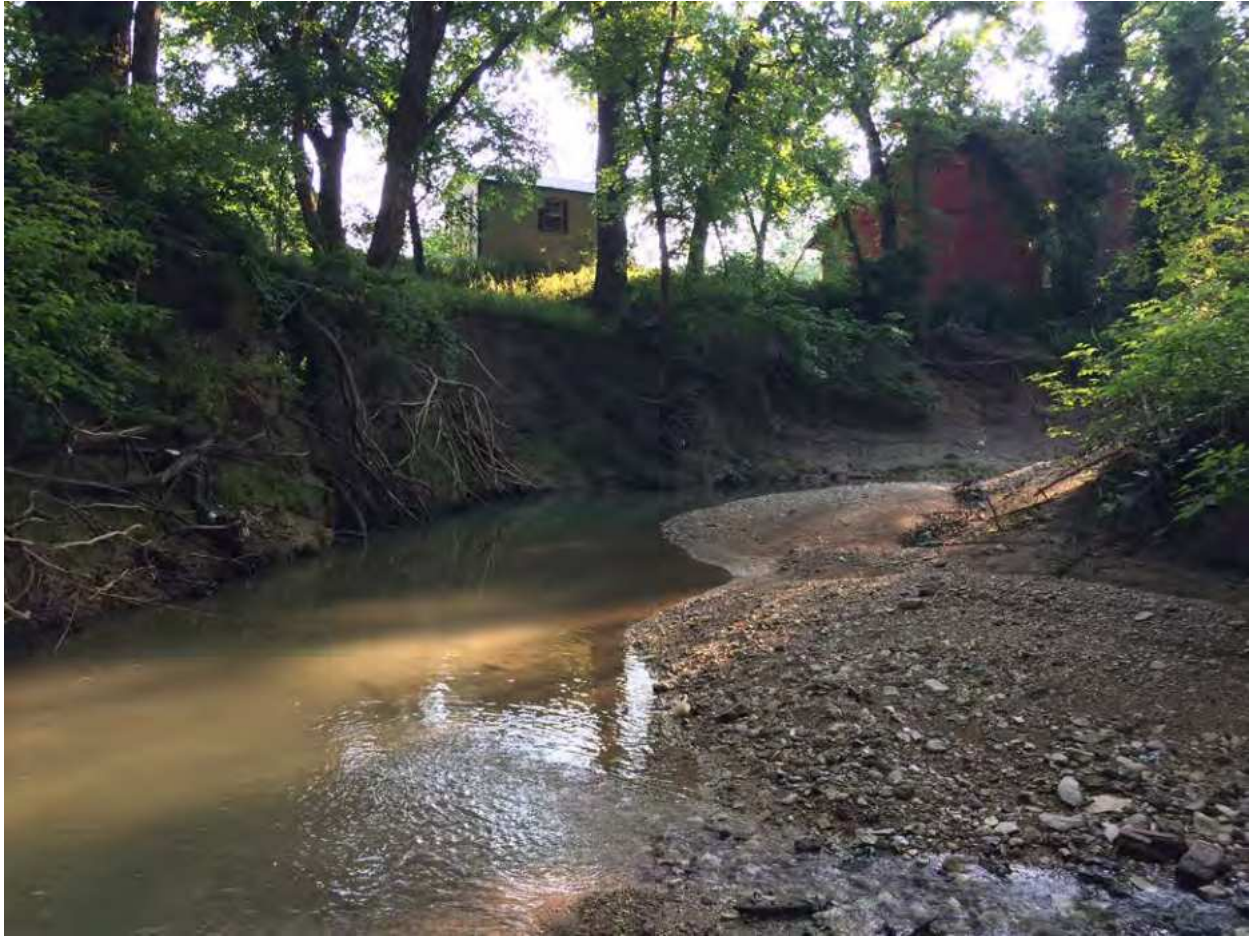
Site 5

This site is located just north of site 4, along another sharp bend in the stream. The bank is approximately 14 feet in height and nearly vertical due to erosion. No vegetation is left in the eroded bank with the exception of overhanging tree roots. Aggradation was observed in the opposite side of the stream, caused by sediment deposition due to lower velocities along the inner bend. A shed is located a few feet from the top of eroded bank. Another secondary wood structure is located a few feet further. The main dwelling is located over 150 feet away from the stream. The 100-year channel velocities in this area transition from 18 to 5 feet per second, around the stream bend. The sharp bend helps to slow the velocity down at the cost of eroding the bank. Erosion is expected to continue along the stream bend, taking additional overbank area, trees, and possibly one of the secondary structures closer to the creek bank.

Bank erosion in the outer bend, and aggradation in the inner bend.

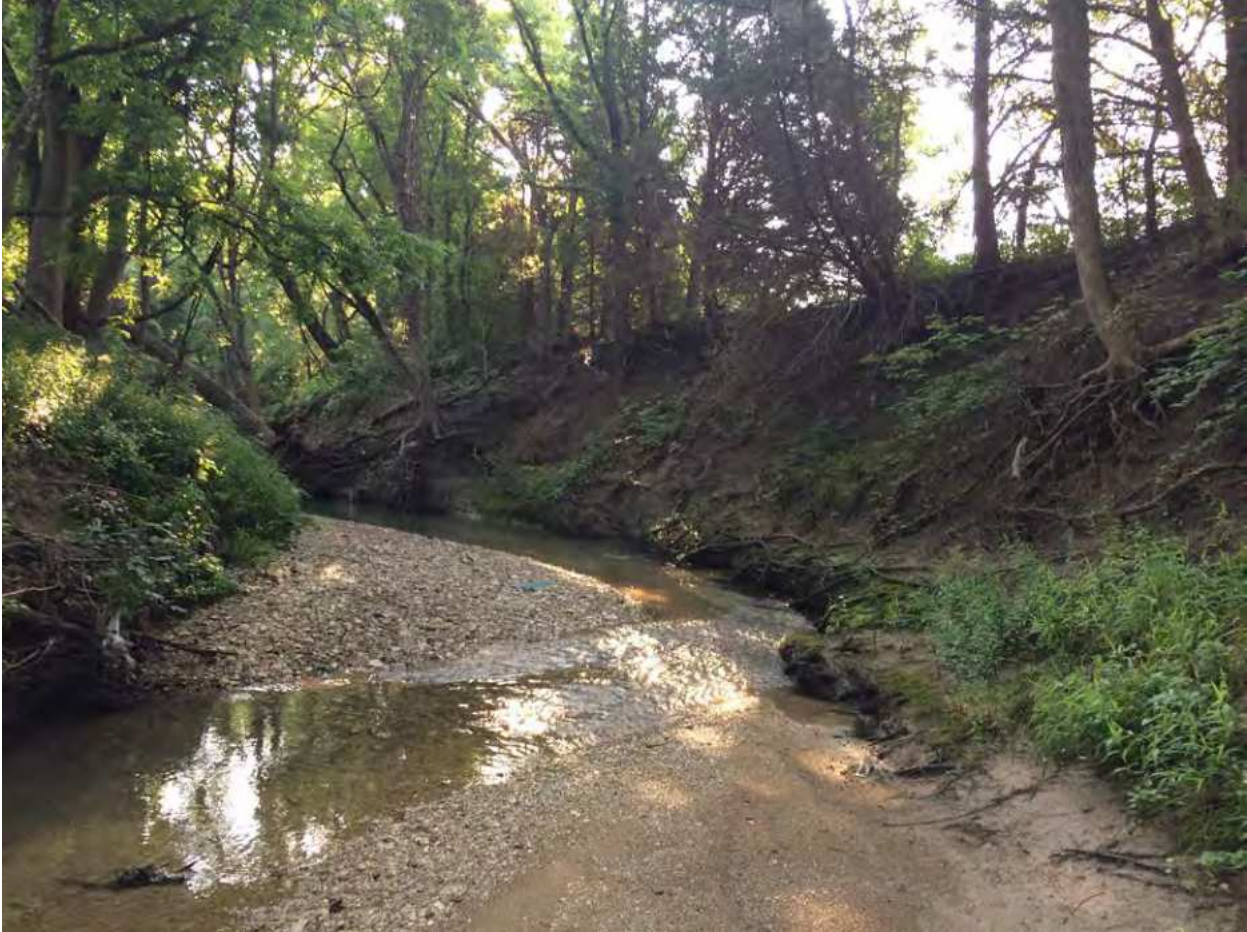
Site 6

This site is located about 200 feet east of site 5. Bank height, material and vegetative cover is similar to site 5, but the banks are not as steep. Aggradation was observed along the inner bend, and degradation along the outer bend. No structures were visible near the stream. The main dwelling is more than 100 feet away from the stream. The average channel velocity is 3 feet per second as shown in the hydraulic model. This is considered a low velocity, not expected to cause streambank erosion. Headcutting was observed in this area suggesting the stream profile has dropped.

Bank erosion in the outer bend, and aggradation in the inner bend.

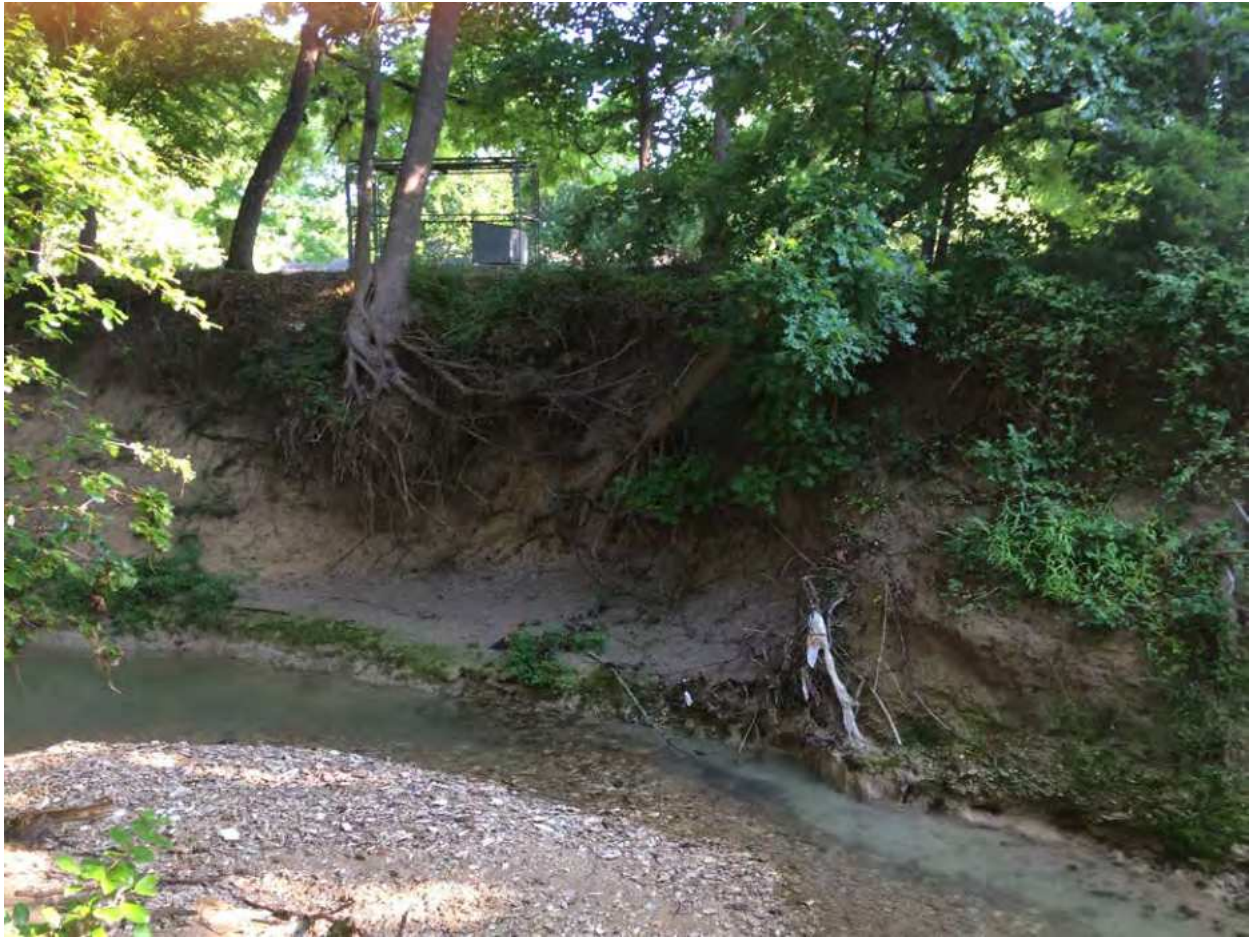
Site 7

This area is located about 300 feet east of site 6. Severe erosion was observed around the inner stream bend, with no vegetative cover left and trees being uprooted. The bank material appears to be the erodible sandy clay. The bank is nearly vertical and about 14 feet in height. Channel velocity in this section of the stream is approximately 9 feet per second, which is considered high and erosive for a natural stream. The main dwelling in the property is about 100 feet away from the eroded streambank.

Severe erosion at stream outer bank
